BURNED-AREA REPORT
(Reference FSH 2509.13)**PART I - TYPE OF REQUEST****A. Type of Report**

PART II - BURNED-AREA DESCRIPTION**A. Fire Name:** Beaver Fire**B. Fire Number:** CA-KNF-005497**C. State:** CA**D. County:** Siskiyou**E. Region:** 5**F. Forest:** Klamath**G. District:** Oak Knoll District**H. Fire Incident Job Code:** P5H93T**I. Date Fire Started:** 07/30/2014**J. Date Fire Contained:** 08/31/2014**K. Suppression Cost:** \$27.2 million as of 8/31/2014**L. Fire Suppression Damages Repaired with Suppression Funds**

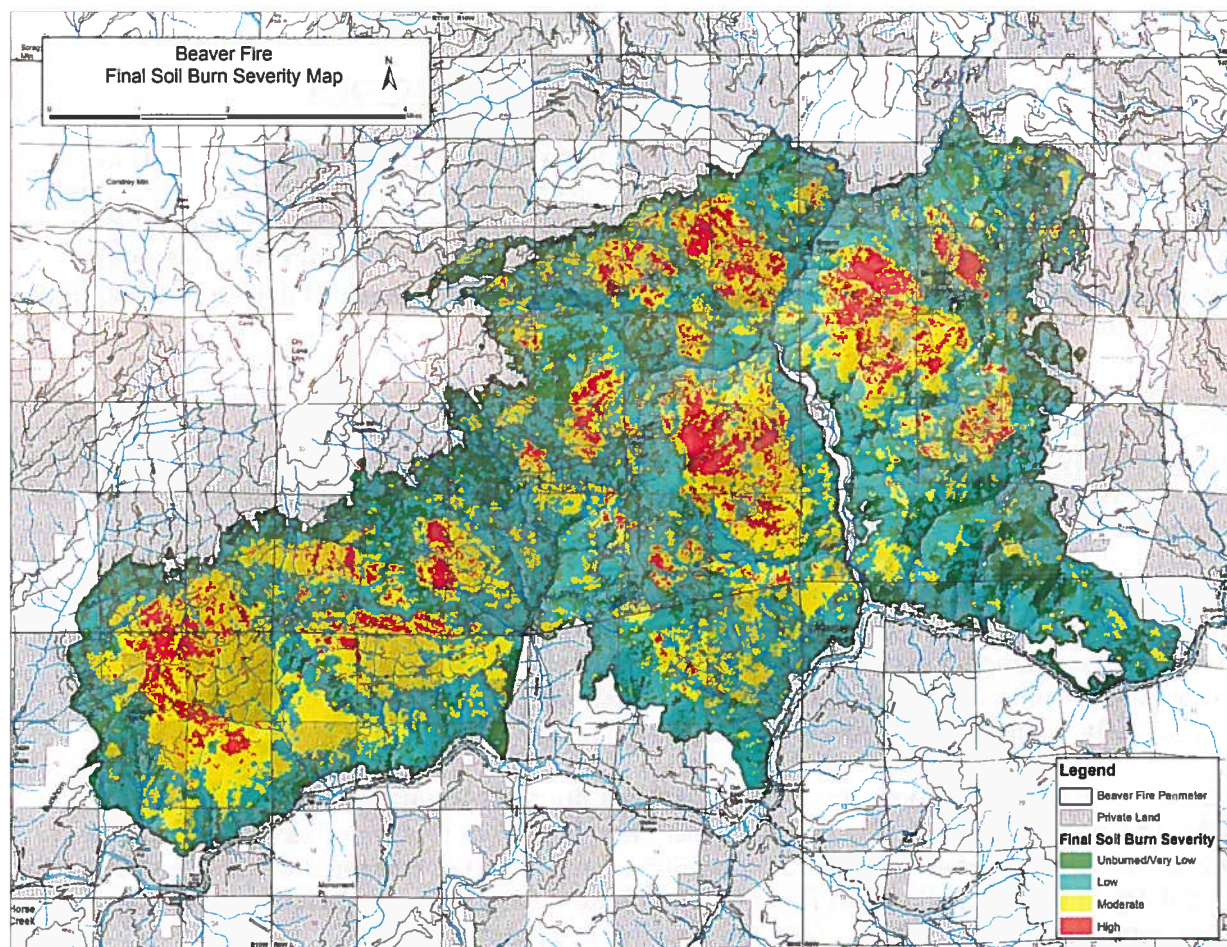
A. Burn Severity (acres): (very low) 5,131 (16%) (low) 16,138 (50%)
(moderate) 9,209 (28%) (high) 1,989 (6%)
